Combined Reports on St Lawrence Church, Stratford Sub Castle, Wiltshire.

**A survey of Historic Graffiti St Lawrence Church,
Stratford Sub Castle, Wiltshire**
Jamie Ingram

**Report on St Lawrence, Stratford sub Castle Church Screen and Fittings,
Box Pews and Doors**
Penny Copeland and Jude Jones

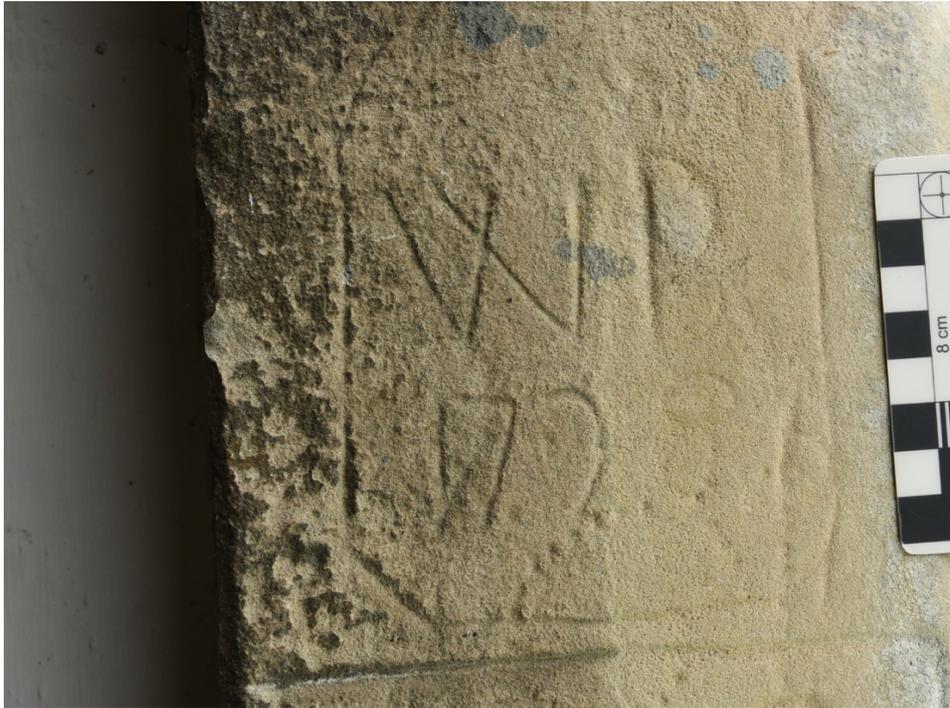
Figure 1. Probable memorial mark to WB 1728, south porch (authors own image 2017)

Marks like these (Figure 1 and Figure 2) can be found on many churches through the country and have been shown to correspond to entries in death entries in parish records. It is therefore likely that these and two more that have been identified on the exterior of St Lawrence are similarly attributable to being memorial marks.

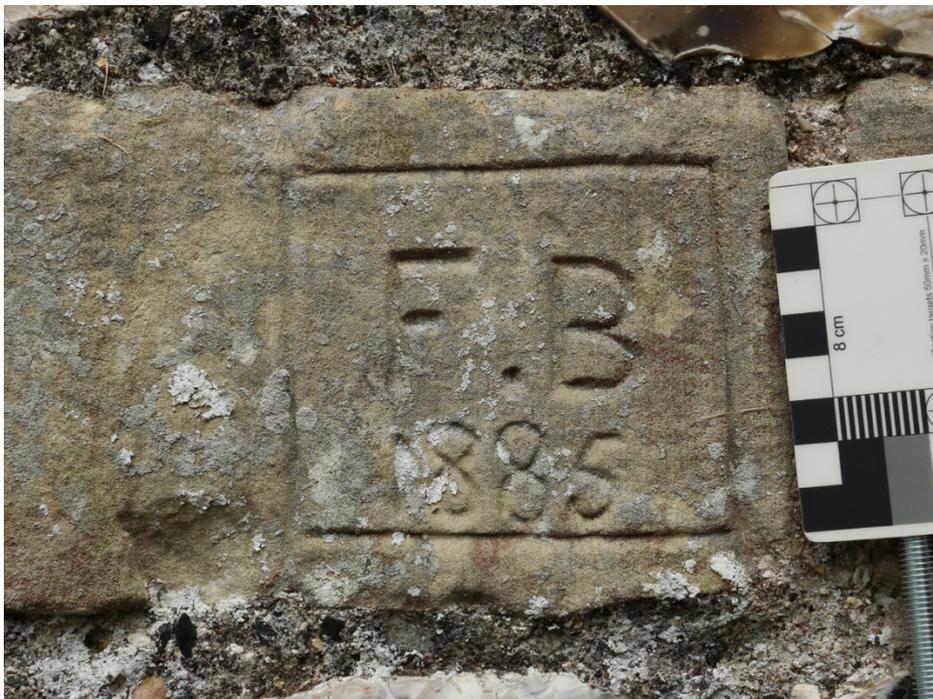
Figure 2. Possible memorial mark to FB 1885, south wall (authors own image 2017)

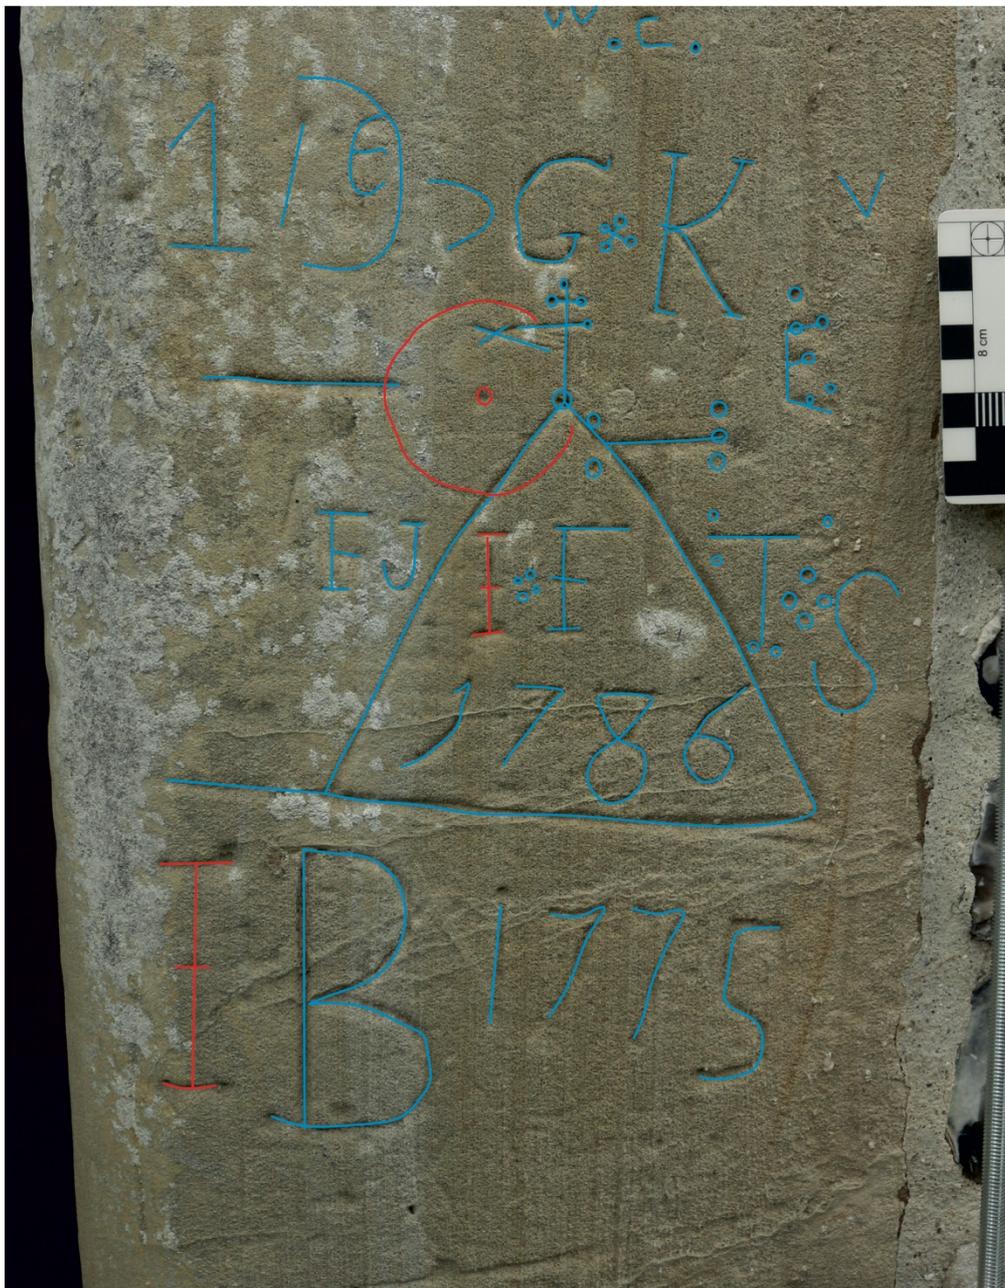
Figure 3. A complex composite of marks, south porch (authors own image)

This complex panel (Figure 3) appears to be a multi period composite comprising of a series of later dates, initials and geometric patterns over cutting, and in some cases reusing, older marks. It is probably that the compass drawn mark and the two archaic J forms, all shown in red, are significantly earlier than the other marks. The significant number of crosses present are impossible to date and therefore could relate to either the earlier or later collection of marks.

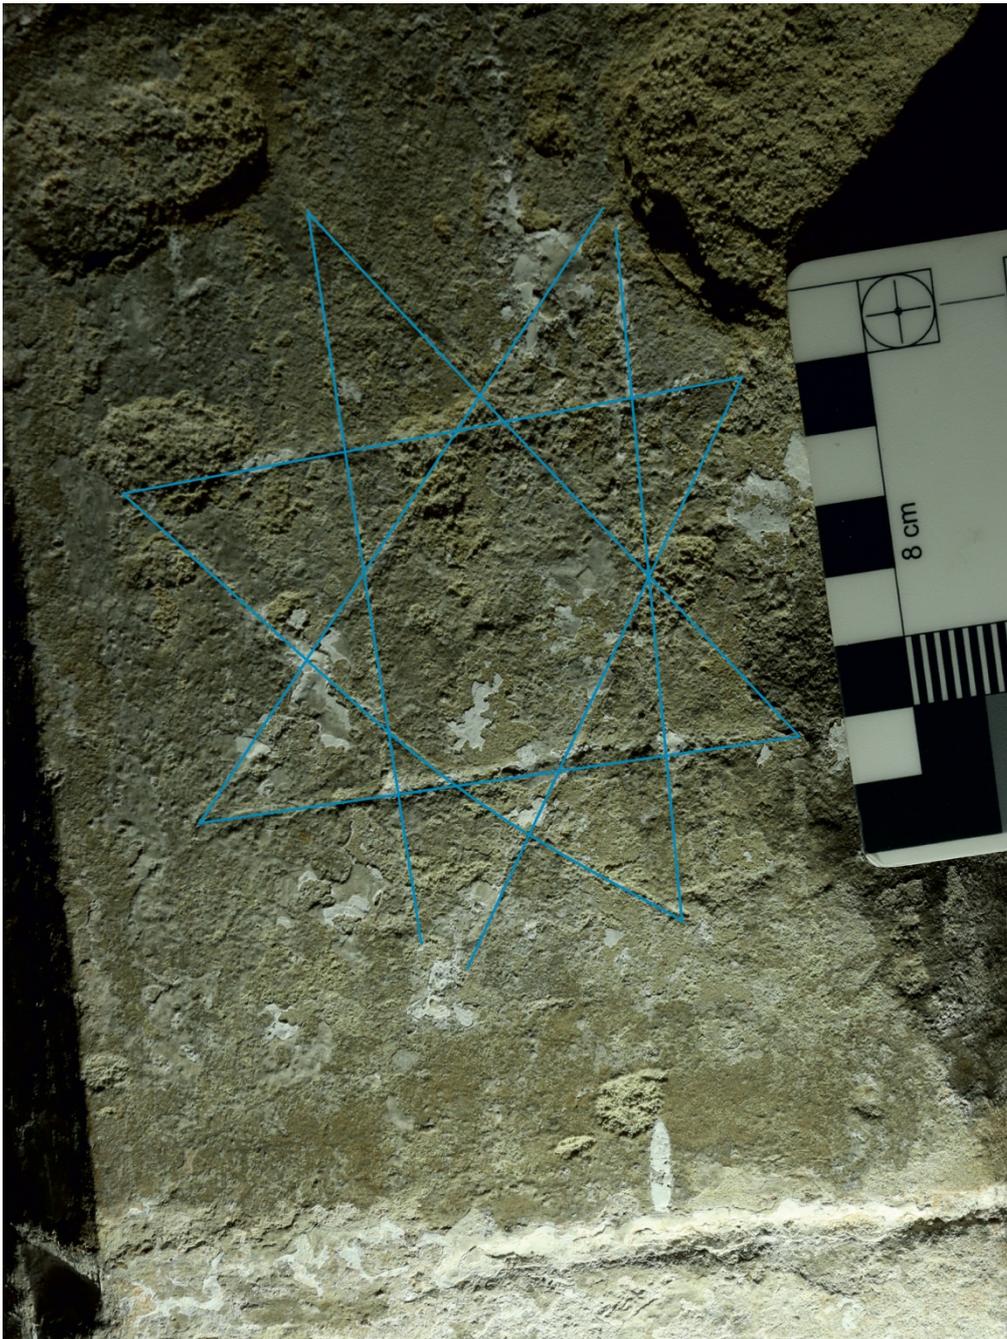
Figure 4. Octagram low on the interior of the south porch (authors own image 2017)

Less common than the pentagram, it is likely that this eight-pointed star (Figure 4) is similarly an apotropaic mark intended to provide some form of spiritual protection within the entrance to the church.

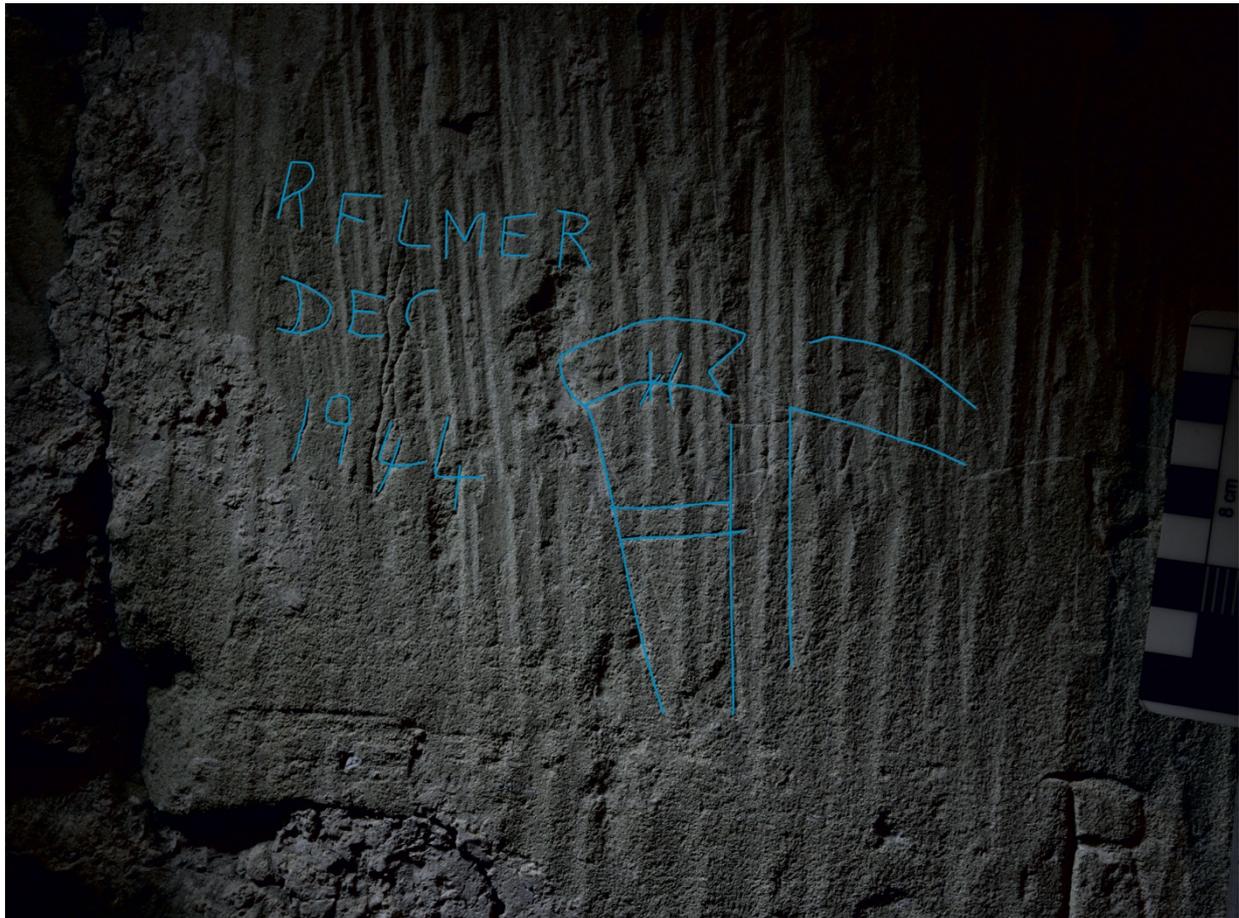
Figure 5. Probable World War 2 mark, clock room in tower (authors own image 2017)

It is likely that this mark (Figure 5) relates to the troops camped in the area as part of the invasion of occupied Europe. The identity of the geometric forms is unknown.

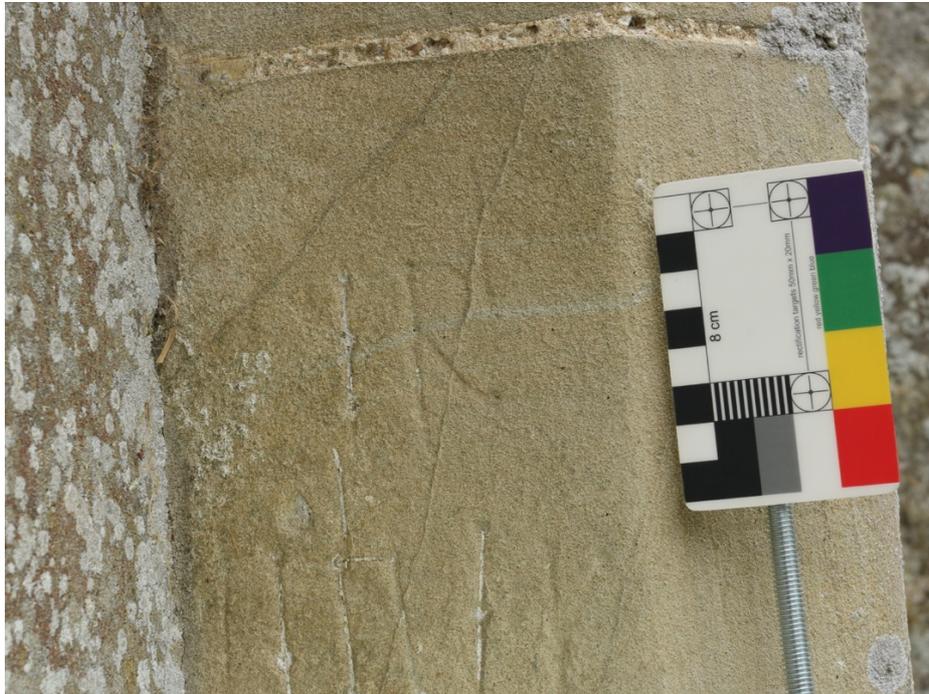
Figure 6. Votive mark IR at north door (authors own image 2017)

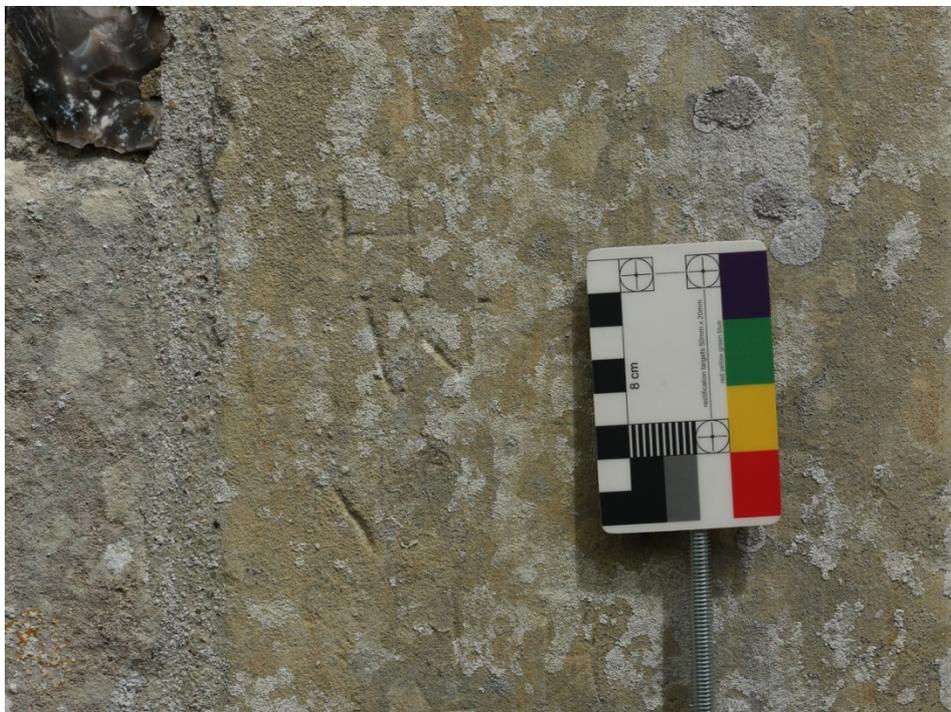
Figure 7. Votive mark VV at west door (authors own image 2017)

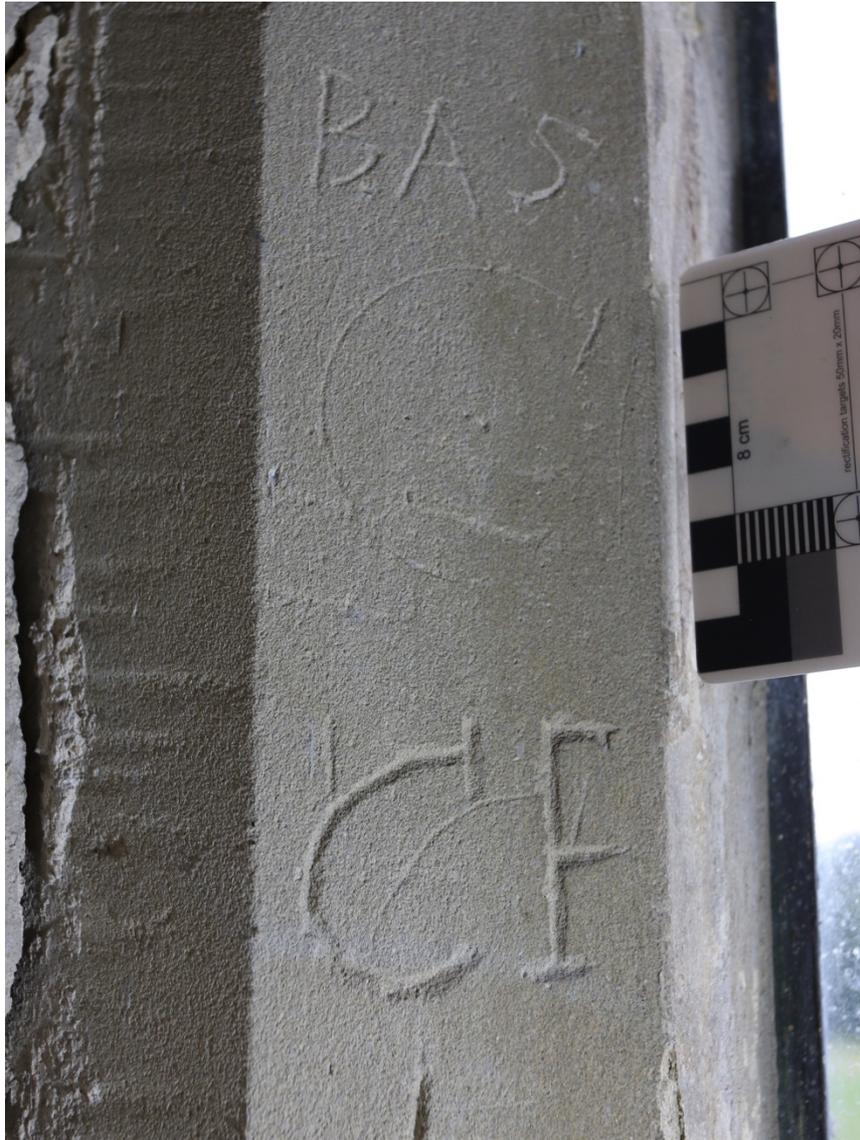
Whilst it is generally accepted that the tower dates from the reconstruction work in 1711 it is probable that some of the graffiti present predates this. Of particular note is the compass drawn mark on the central window mullion (Figure 8) which would appear to be earlier than the surrounding text inscriptions. Also present is a votive I (J) on the opposite side of the mullion (Figure 8), this votive mark is in a clearly different hand to the added B which also appears to overcut it indicating that it is a later addition to modify an existing inscription and reform it into a new meaning.

Figure 8. Compass drawn mark on mullion (authors own image 2017)

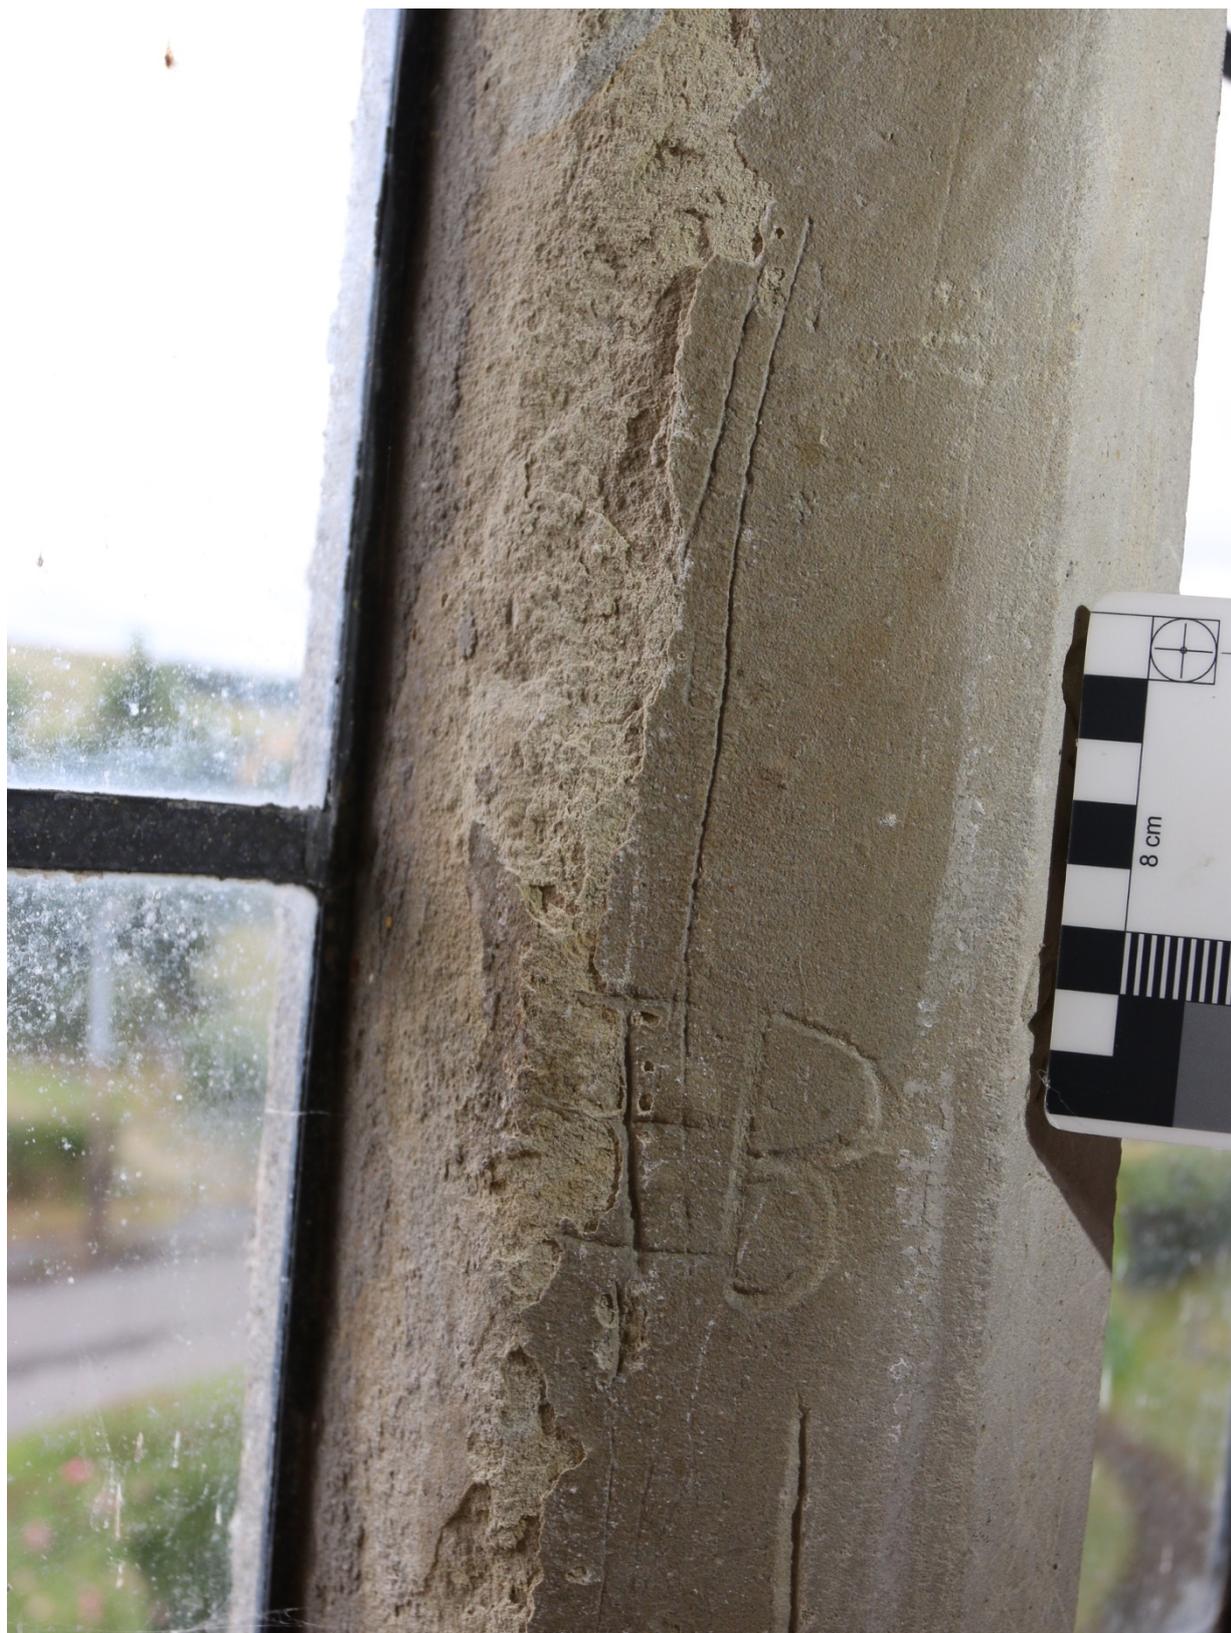
Figure 9. Votive I(J) on window mullion, clock room in tower (Authors own image 2017)

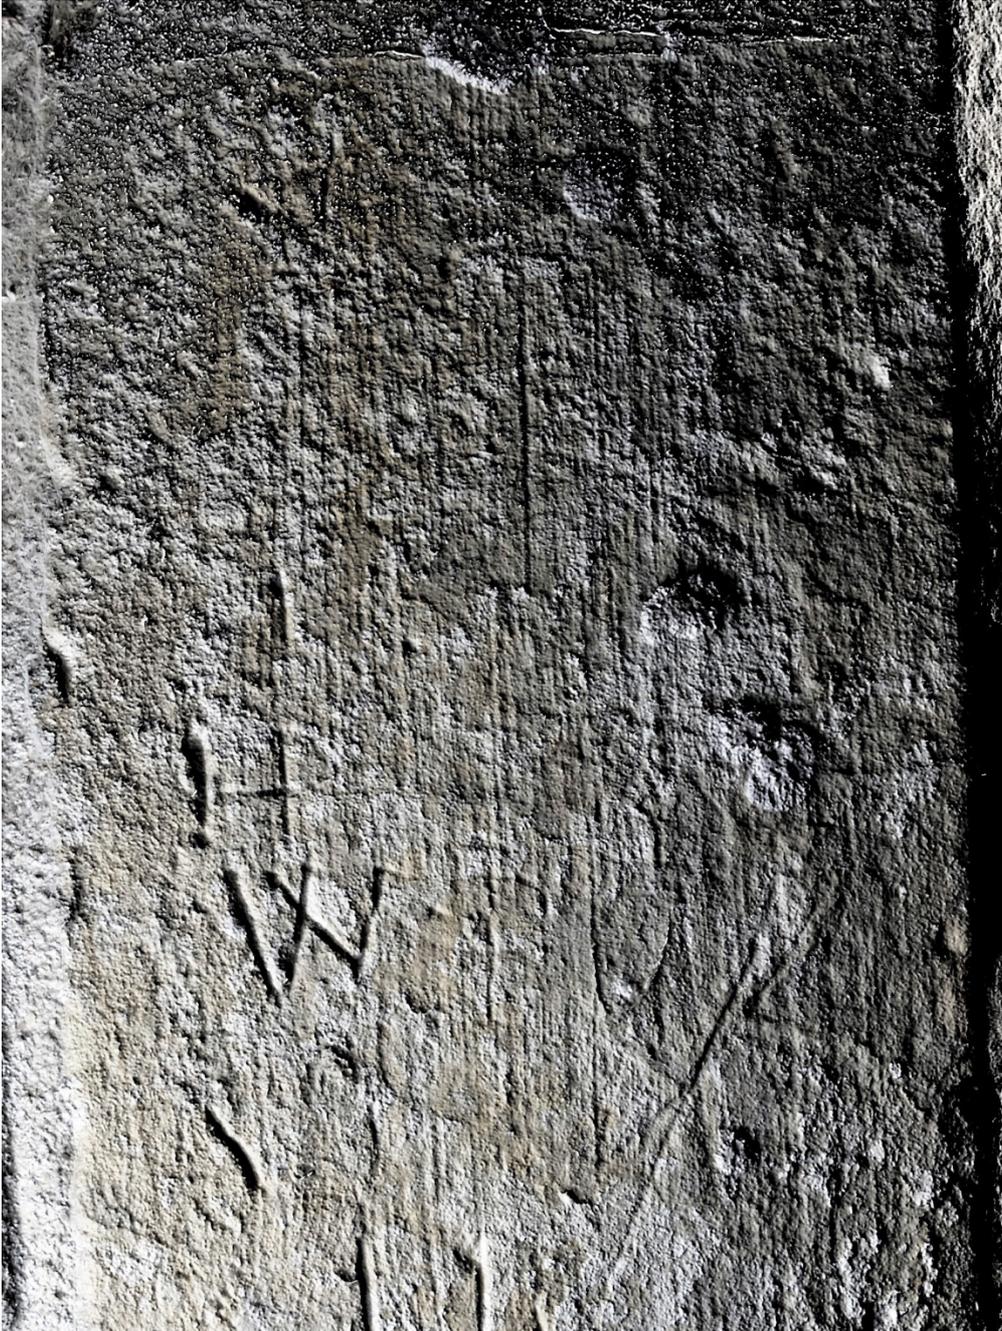
A limited number of selected panels of graffiti were recorded using RTI, this technique enhances the photographic imaging and can reveal otherwise lost marks. The results are particularly strong for a panel that is located on the west side of the external arch that forms the south porch. These results reveal a complex design constructed from a series of connected circles that probably form a representation of the spiritual or celestial world.

Figure 10. Output from RTI file showing possible celestial or spiritual diagram (authors own image 2017)

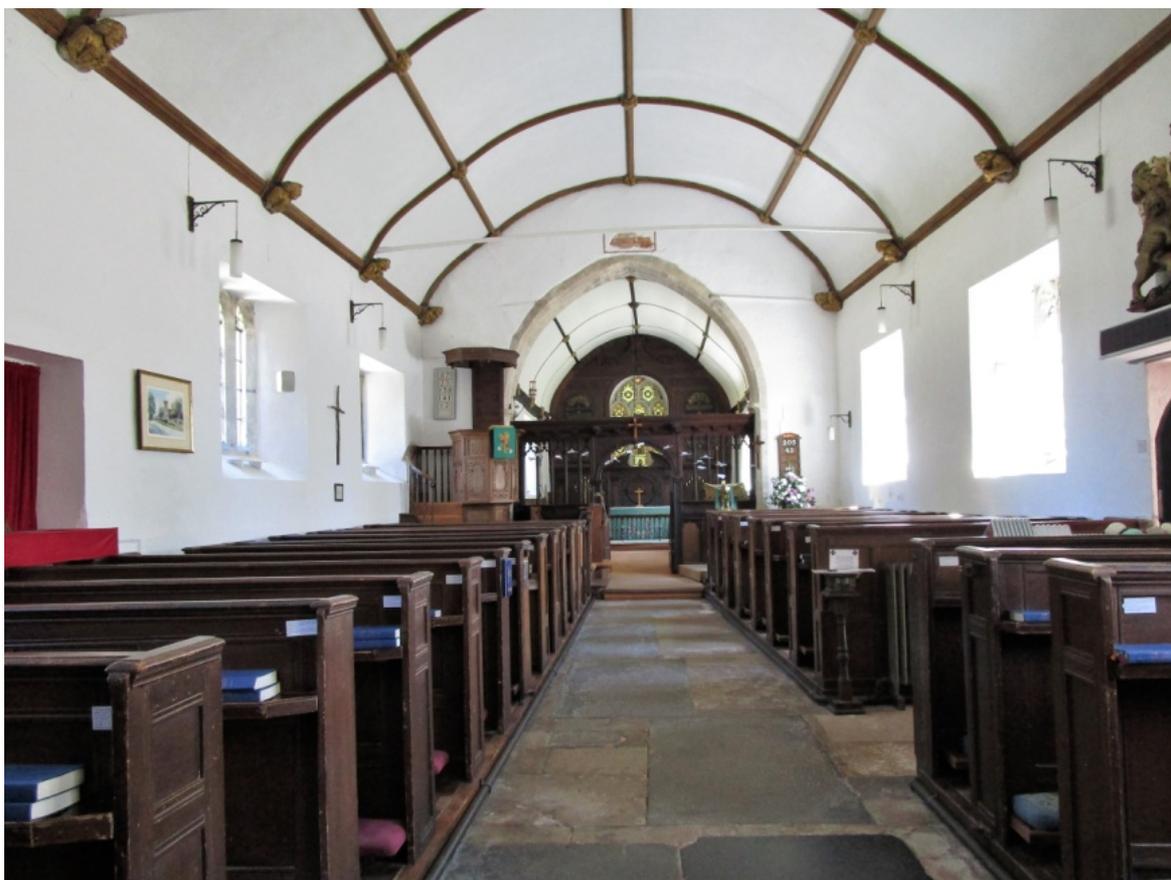
Fig.1 Looking down the nave to the screen

Most of the screen is heavily covered in dark brown paint. On the chancel side, it is clear that some of this paint is “graining” - designed to imitate wood work. It is also obvious in places that the panels have moved fractionally exposing a layer of white – either part of a white paint scheme or gesso as preparation for a later wood effect (Figs. 3 and 4). White (or grey) painted panelling is commonly found in early-mid 18th century churches (a good example is the chancel pew, pulpit and gallery panelling in St James-without-the-Priory-Gates, Southwick, Hants which, like St Lawrence, had a complete make-over in the early years of the 18th century (Pevsner and Lloyd 1967: 604-9, Jenkins 2000 254-5, www.stjamesouthwick.org.uk). The church retains these changes into the present - see Fig.5). Graining (used as an alternative in 17th century panelling) came back into fashion by 1800 (Parissien 1999: 175, 180) so this may help date the present scheme.

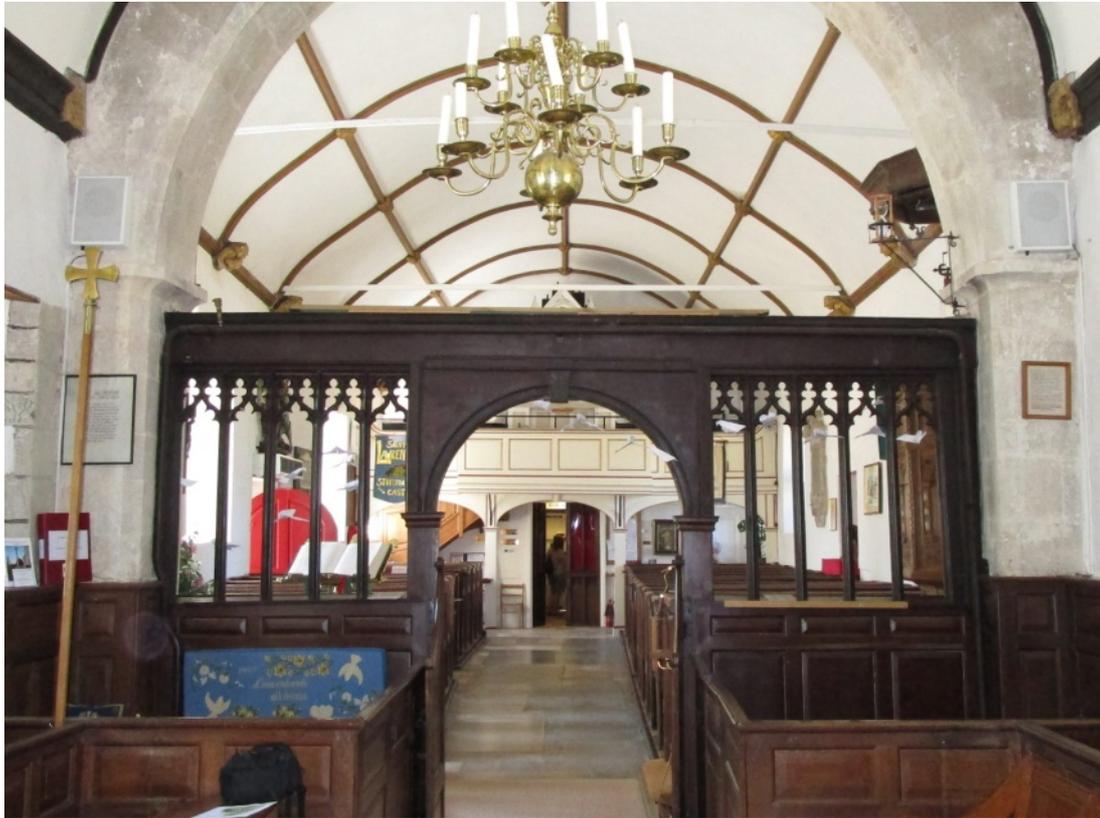
Fig.2 Closer east-west view of the screen from the chancel.

Traces of red and green paint seem to be visible under the brown on the open screen uprights, although these posts have less paint on them than the tracery above, suggesting they are later replacements.

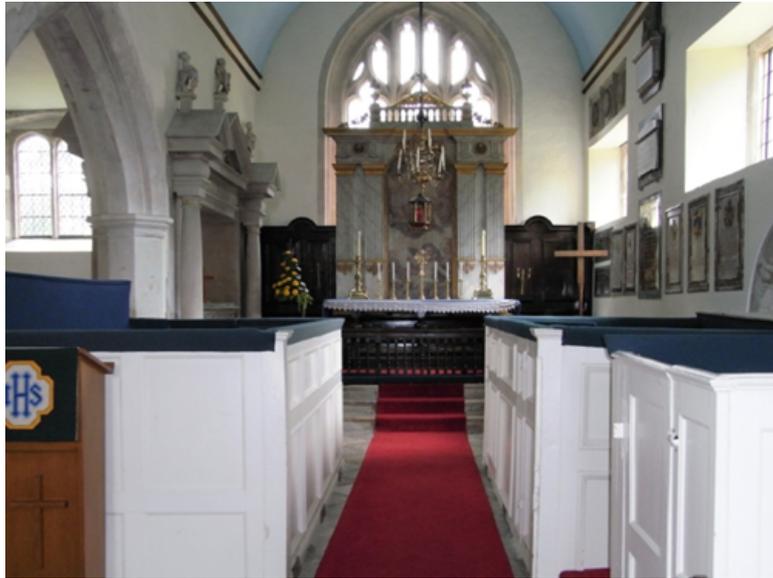
Fig. 5 Norton gentry pews in St James-without-the-Priory-Gate's chancel, Southwick, Hants, showing the effect of 18th century white paint. The men's pew is to the north, arranged in two ranked tiers. The nearer south pew is for the Norton ladies and subdivided into two compartments suggesting one caters for the senior family women and the other for lesser female relations or household members.

the chancel it is possible to speculate that the women sat on one side and the men on the other (see Fig. 5 of *St James, Southwick for the Norton family pews as an exemplar of this system*).

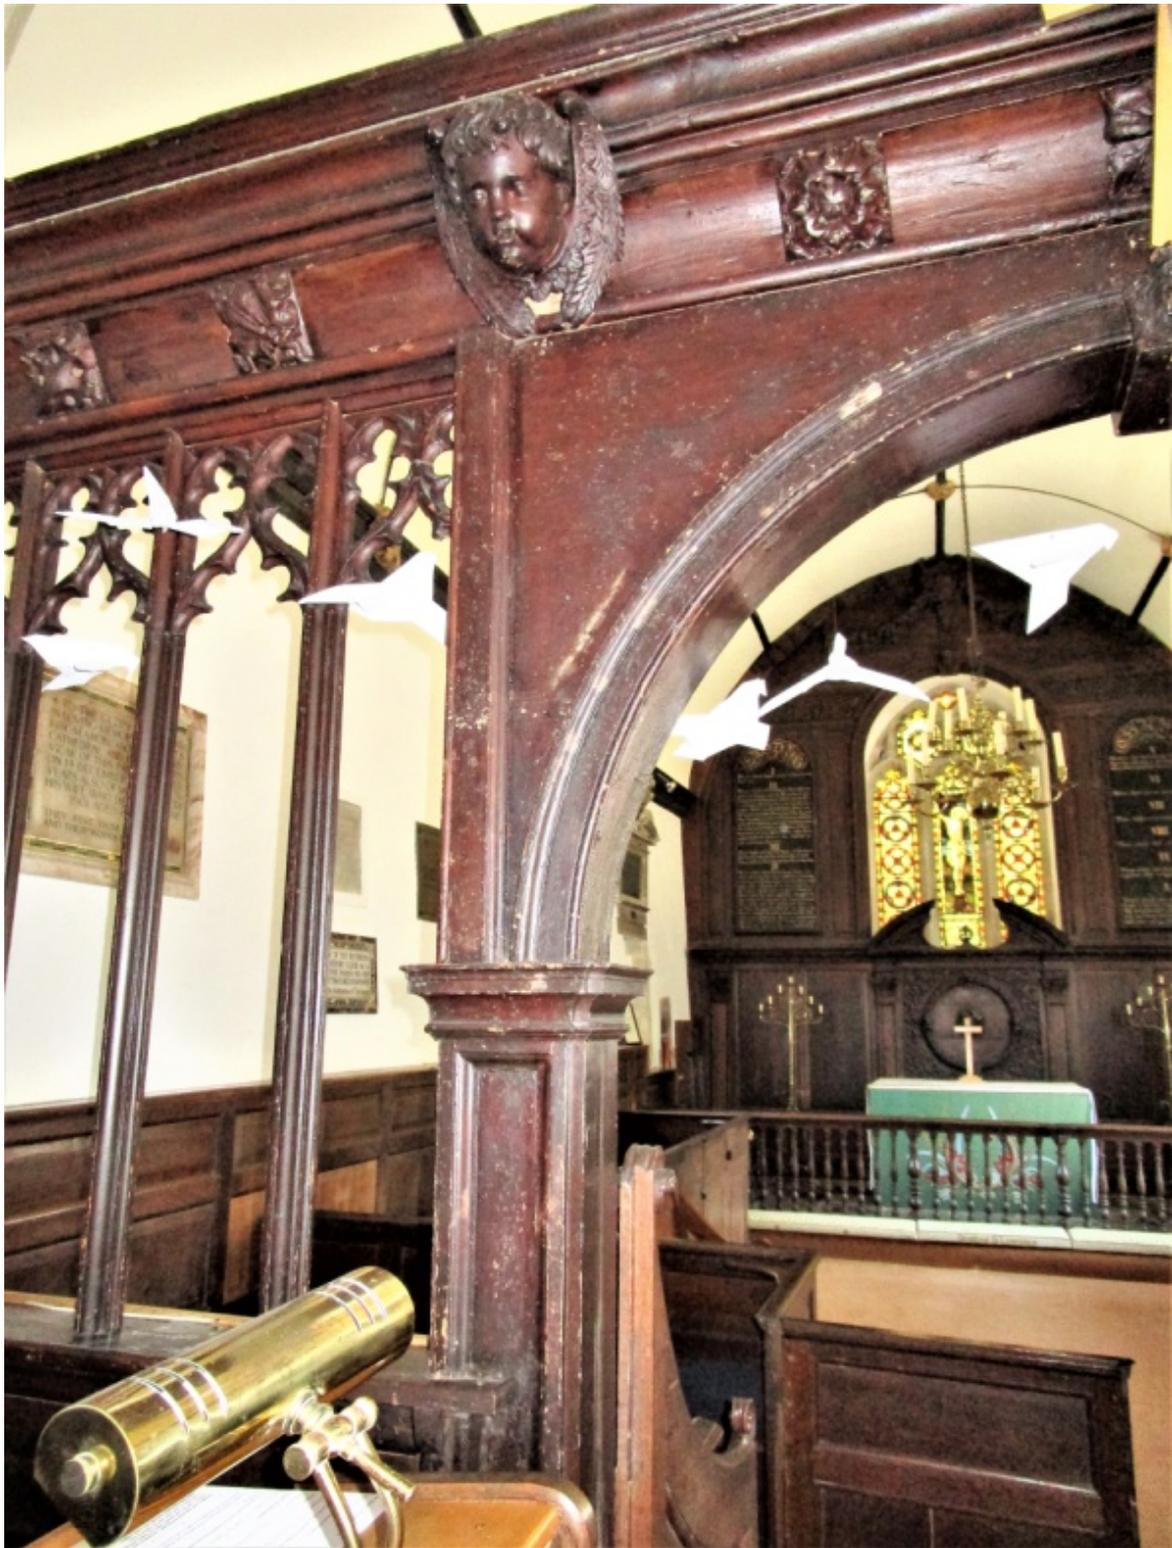
The rood beam is ornately moulded but the ornament appears only on one side, facing the nave. The other side has been boarded over with a bead moulding, a possible Georgian alteration. This suggests that the beam has somehow been modified, the boarding concealing the evidence. In addition, the ornaments on St. Lawrence's beam (discussed below) are not symmetrical to the opening. There is an ornament right up against the stone work on the south side, whereas on the north side, the ornament is set away from the wall.

Roses on the ornaments suggests a Tudor date but these are also commonly found on Stuart tomb monuments and architecture into the 18th century, though by this time they are evidence of a more conservative or traditional taste. The dating also applies to the winged cherubs which are similarly found on Tudor/Stuart-early 18th century monumental and decorative church architecture where they are symbolic of the soul, released by death and flying up to Heaven (see Tarlow 1999 and Llewellyn 2000 for mortuary symbolism in monumental church imagery). From their style these would seem to be later examples and possibly contemporary with the insertion of the central classical arch (see Figs. 6 and 7). Fig 8 shows the reredos of the altar at St James, Southwick, featuring a plethora of winged cherubs and painted in the early 1720s by an anonymous Italian artist (Jones 2013b:105). Winged cherub heads are a common mortuary motif found on 17th-18th century tombs, memorials and graves.

Fig. 6 West side of screen showing ornaments on the beam.

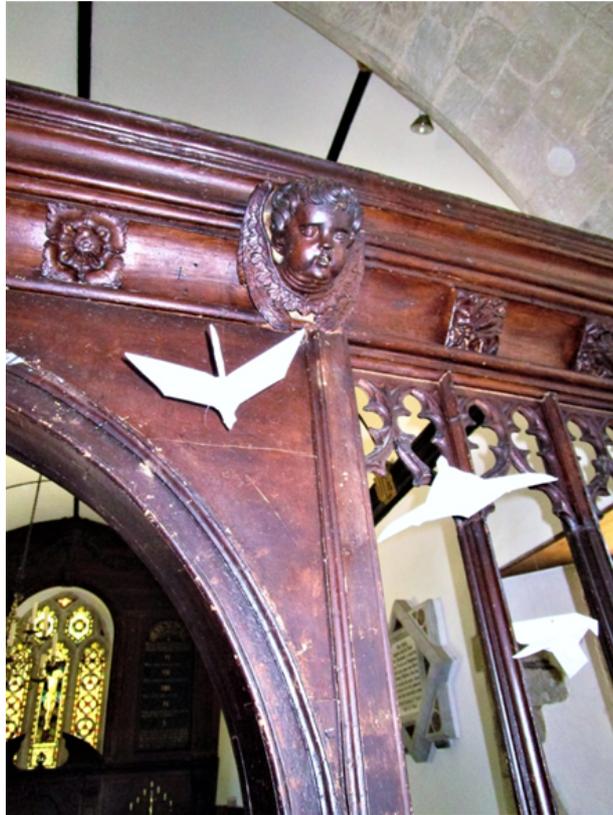
Fig. 7 Rose plaques and winged cherub head ornamental carvings.

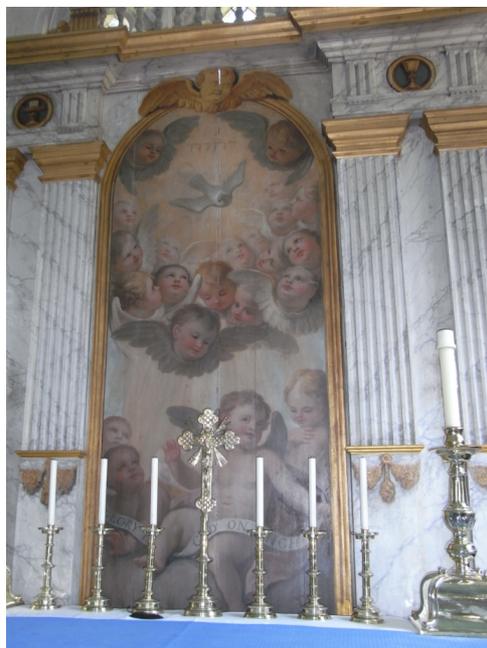
Fig. 8 Painted reredos in St James-without-the-Priory-Gates, Southwick, Hants, depicting winged cherubs ushering the Christian soul up to Heaven

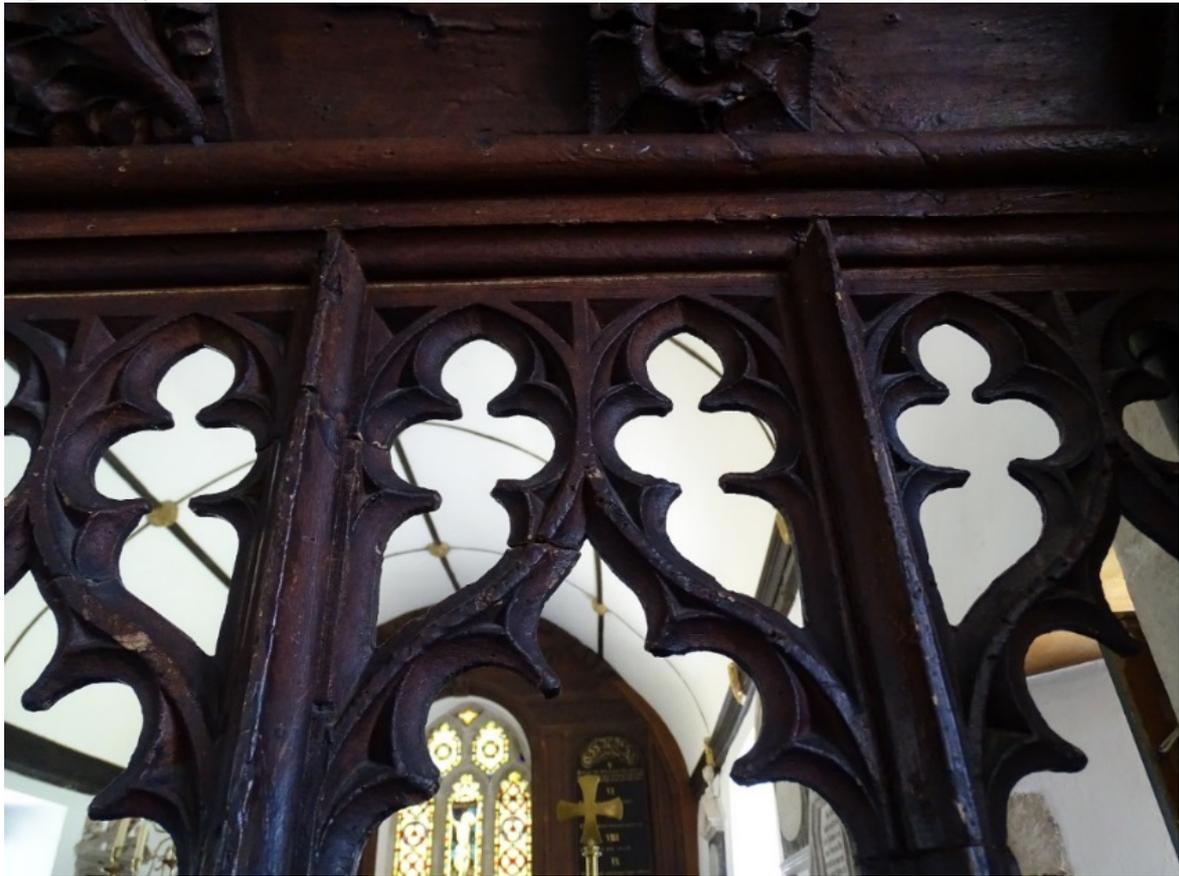
Fig. 9 Top tracery and beam

The tracery fits very well into the beam suggesting that they were constructed as a set. The tracery style is much simpler than many extant examples of 15th century chancel screen tracery found in churches in, for example, Devon and Norfolk and its age contrasts with the later upright mullions that connect up to it. The tracery appears to be oak. One ornamental post (imitation buttress) is present in the upper section of the north corner of the screen, sitting under an ornament on the top beam, appearing very much as the original end to the upper part of the screen (*see Fig. 10*). The equivalent post at the southern end could not be accommodated in the available space indicating that the screen has been cut down. The similarity of the tracery and upper panels to perpendicular decoration that one can find on table, chest and wall tombs of the 14-15th centuries suggests that it is late medieval.

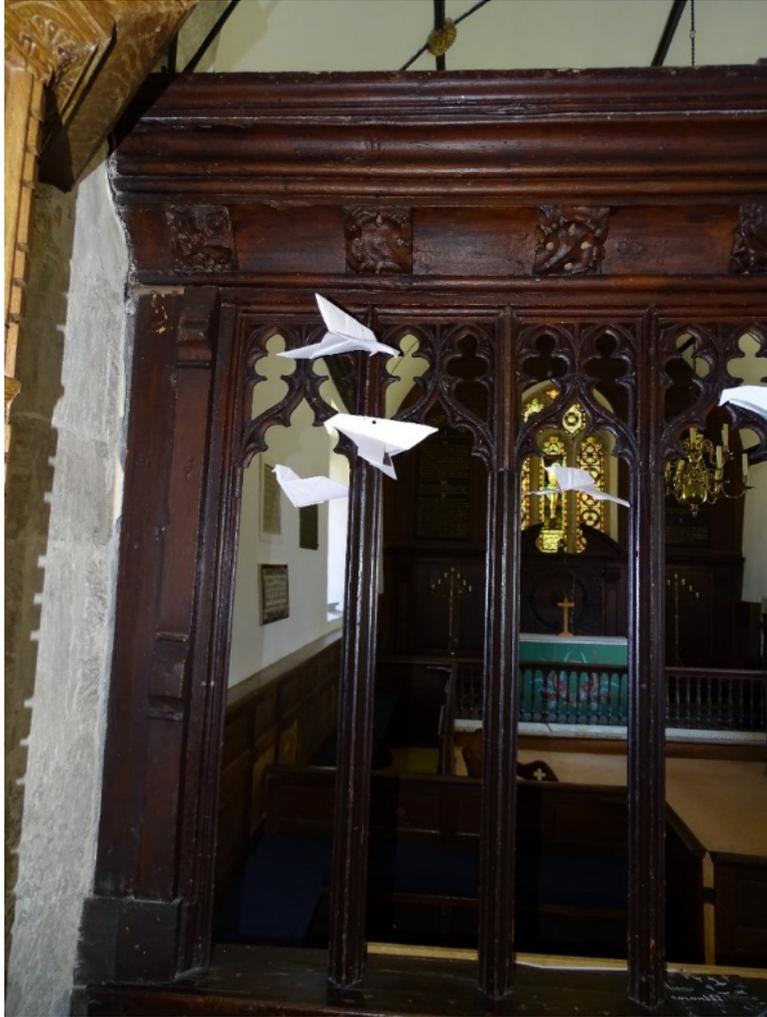
Fig 10 Northern end of the screen showing the imitation buttress and arrangement of ornaments.

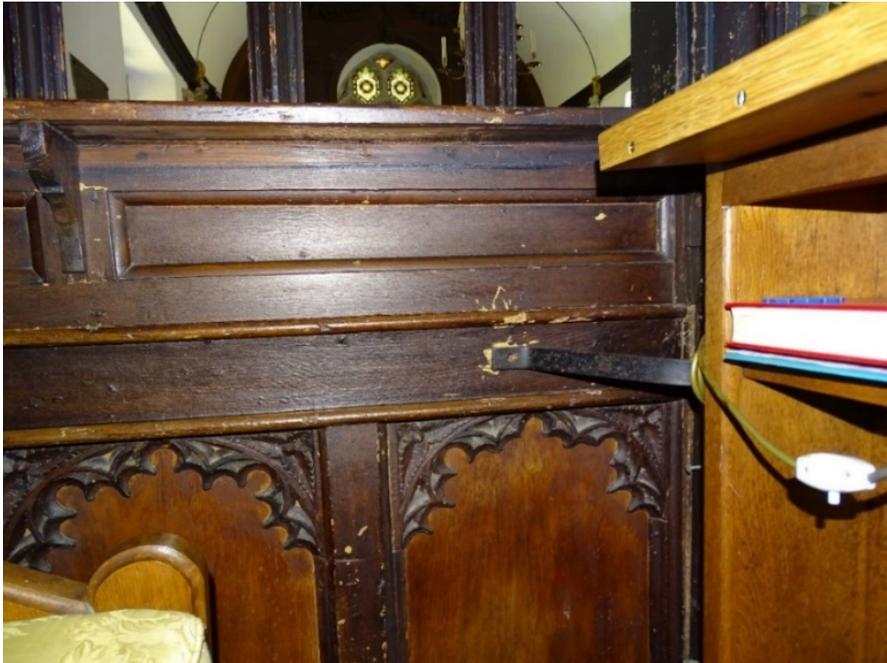
The central band below the upper tracery incorporates narrow panels with quarter bead moulding. This moulding, very similar to that on the west and south doors, is likely to be Georgian and constructed out of softwood (*See Fig. 11*).

Fig. 11 Central band with recessed panel with quarter bead moulding above lower band.

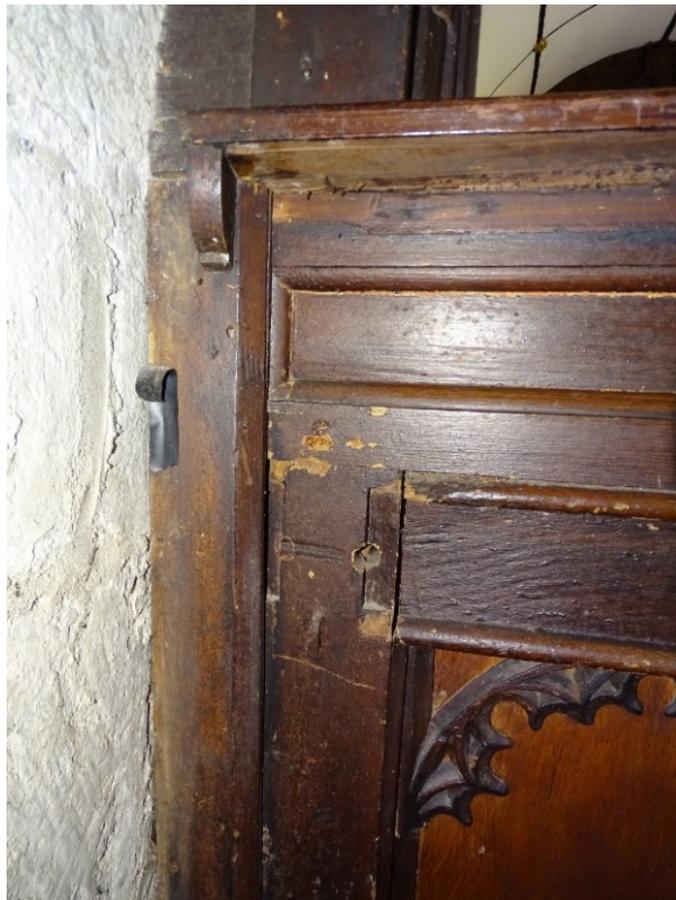
The lower band has evidence at the northern end against the arch that it has come from another screen – a junction and post very close to the wall. The junction of two beams with a post at this point is an extremely unlikely construction. This also indicates that all of the lower tracery panels are from another location (*See Fig. 12 below*).

Fig. 12 Lower post with peg holes from the insertion of the lower band on either side. The band to the north has been severely truncated by the wall and frame

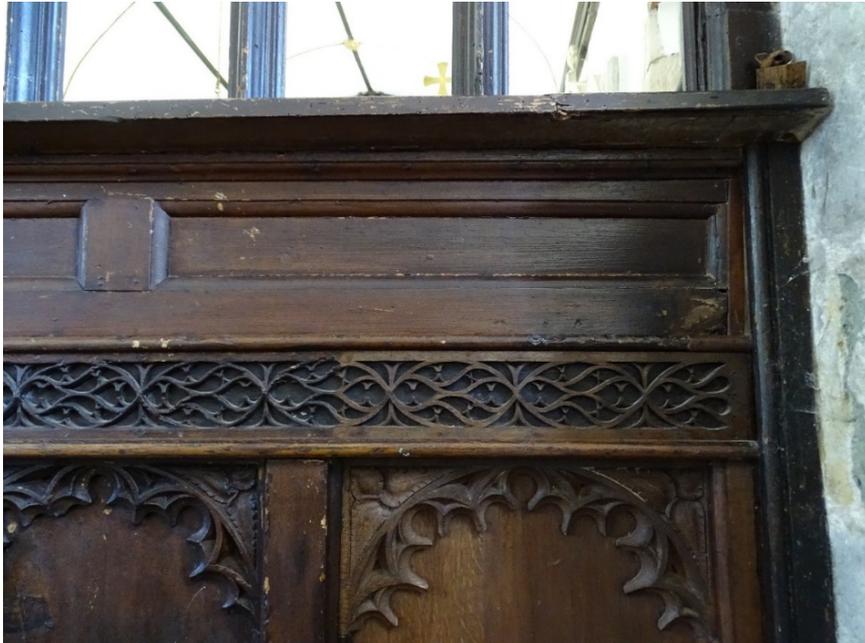
Fig. 13 Fretwork design on lower band with replacement at the southern end

The southern half of the band has a very fine piece of carving on the west side – very flowing and elegant, suggestive of the Order of the Garter (*see Figs. 13 and 14*). It has been lengthened at some point, and while that replacement is very well done and shows how it was made by a subtraction technique, it is slightly thicker and unpainted. We have not yet found a direct comparison but there are a wide variety of decorated bands of equally complex designs on other chancel screens. The back of this section is panelled softwood painted dark brown over gesso or white lead.

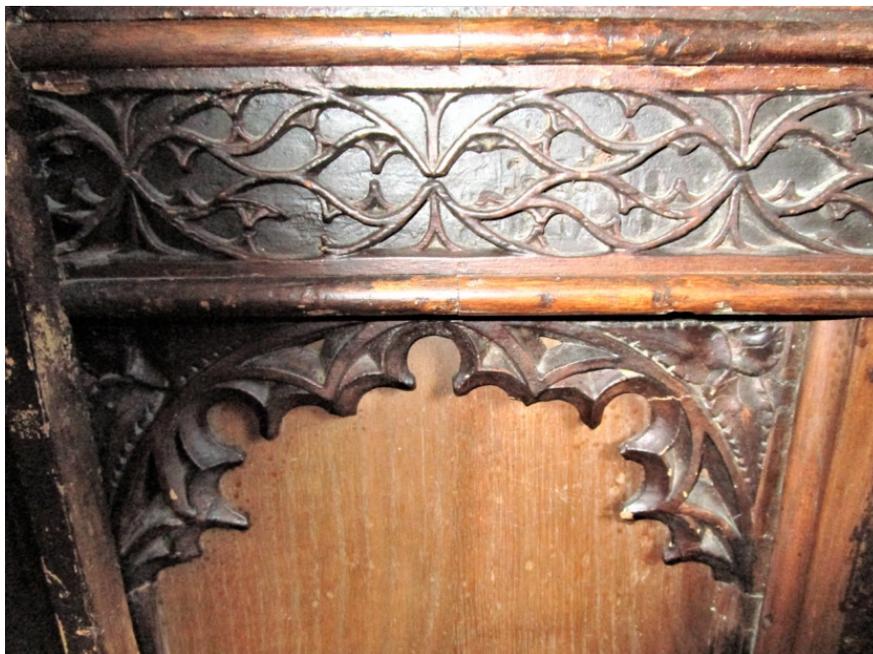
Fig 14 Detail of band and dado/lower panel tracery
