Combined Reports on St Lawrence Church, Stratford Sub Castle, Wiltshire.

**A survey of Historic Graffiti St Lawrence Church,
Stratford Sub Castle, Wiltshire**
Jamie Ingram

**Report on St Lawrence, Stratford sub Castle Church Screen and Fittings,
Box Pews and Doors**
Penny Copeland and Jude Jones

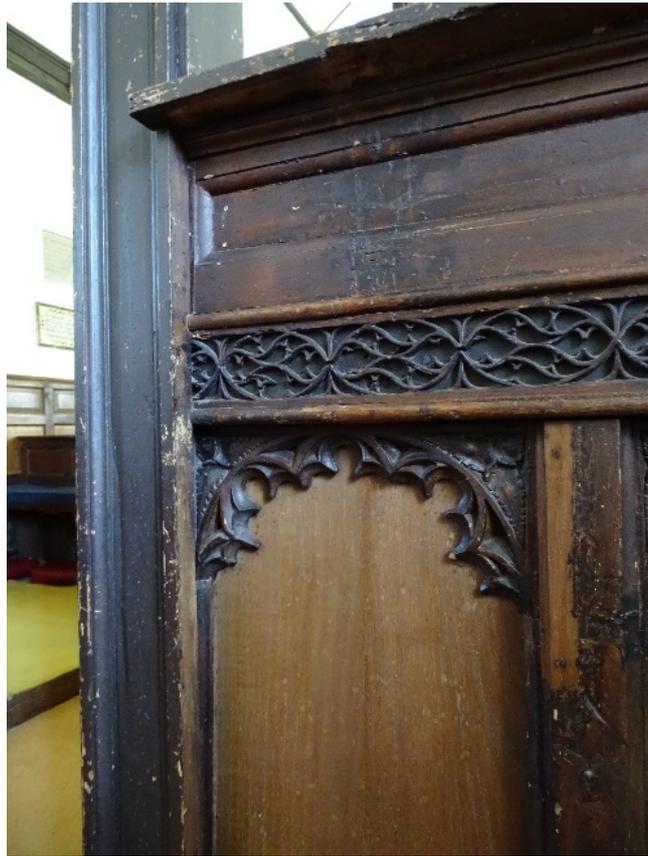
Fig. 15 Northernmost tracery and panel of the south side of the screen's dado showing the overlap of the arch structure.

This arrangement is not followed here suggesting that pieces come from different screens, perhaps put together with the upper band. The tracery also has wider perpendicular posts than the upper panels and the panels themselves seem more elaborate, with the spandrels and carving indicating a possible late 15th- early 16th century date (which might be contemporary with the 16th century church refitting mentioned in the Victoria County History for Wiltshire if the transom was reused (Critall 1962: 199-213)). The panels are in oak and were designed to be fully enclosed, providing a barrier to both access and view. We have yet to find a researched comparison with the spandrel carvings. The early woodwork has been painted brown, but it may well have originally been brightly coloured and the larger flat panels would have had paintings of saints or patriarchs facing the nave (*see Fig 17*). As nearly all the flat panels have been replaced with oak and other timber in the recent past, the saints may have been taken as art or removed in the later Reformation. Only one of the panels survives but the lowest section has been replaced, possibly due to water damage (*see Fig 16*).

This is later than both the lower and the upper tracery as it sits over part of both on the southern side (see Fig. 15 for example). It is formed from soft wood, in contrast to all the wall panelling and box pews of the chancel.

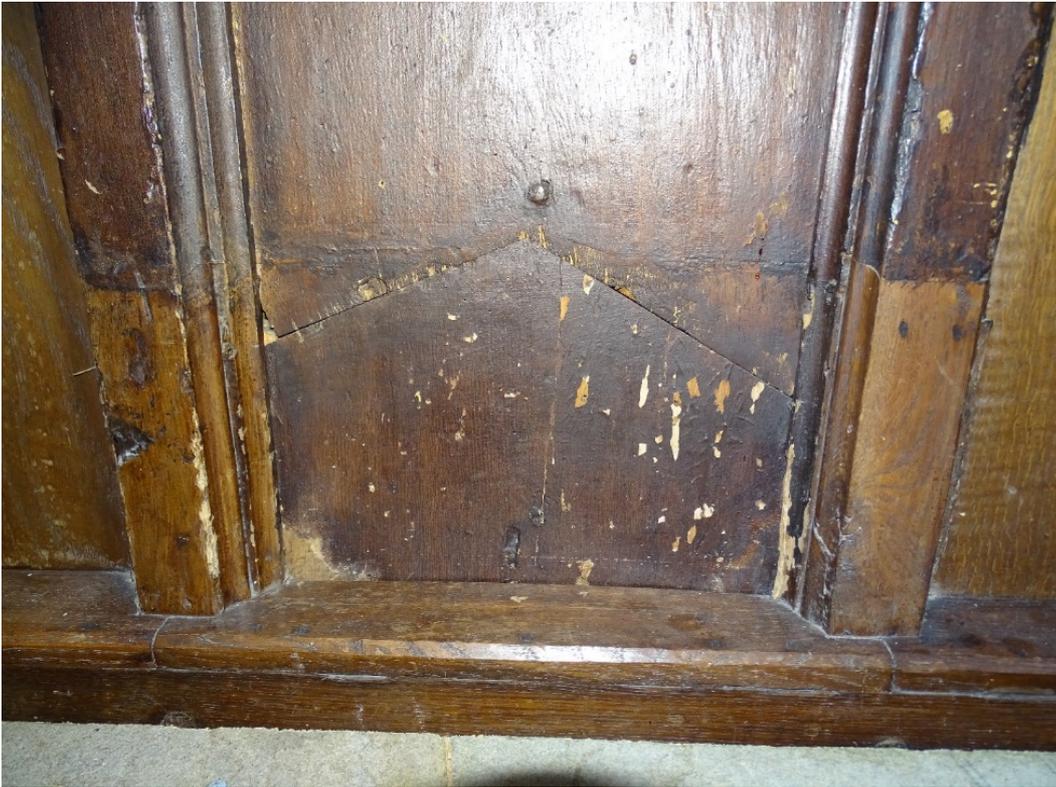
Fig. 16 The earliest surviving panel and the scarfed in elements of panel, sill and muntins.

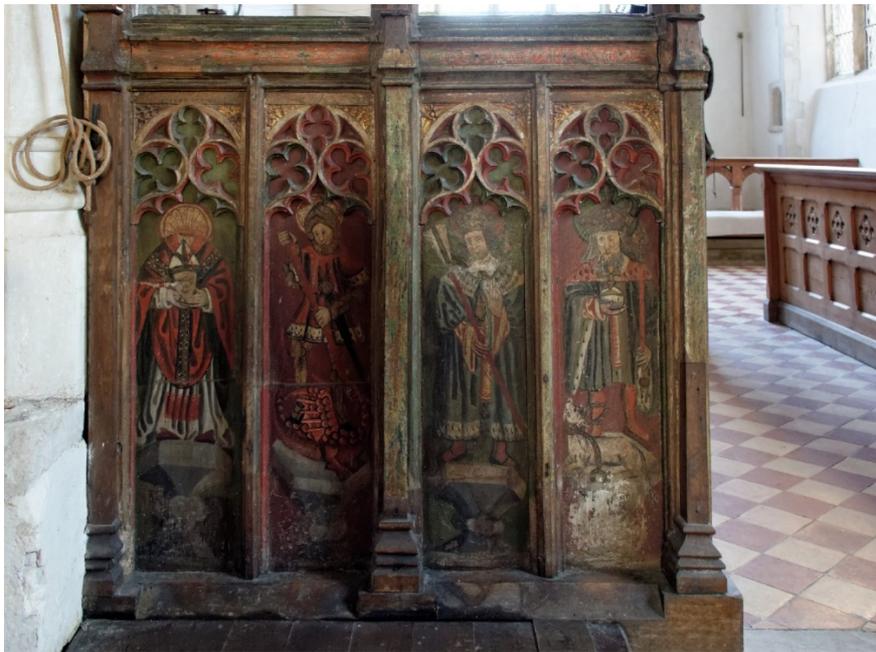
The Stambourne screen including imitation buttresses, similar cusping and spandrels.
<http://www.essexviews.uk/photos/Essex%20Churches/Essex%20Churches%20S-T/Stambourne-Church-Essex-Chancel-Screen.jpg>

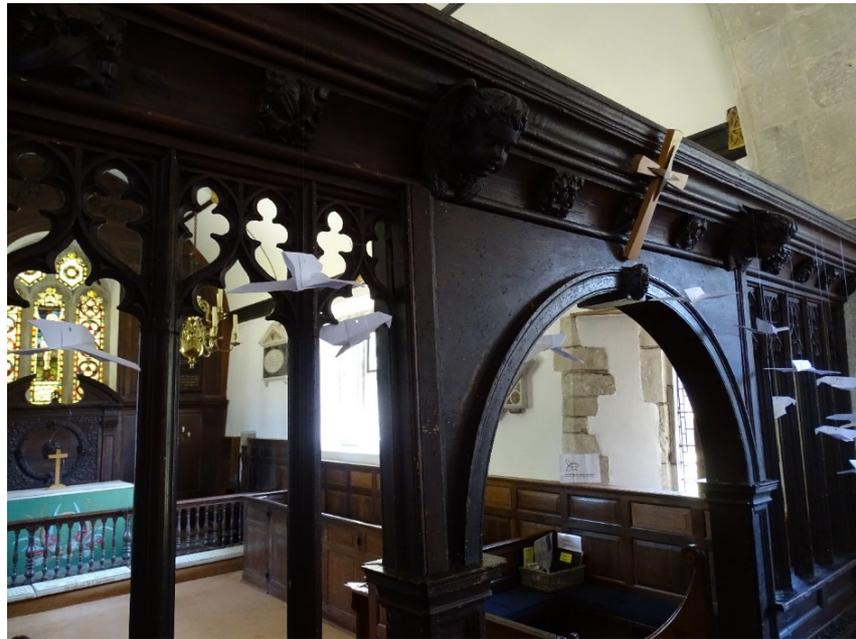
Fig. 18 Neoclassical arch inserted into gothic screen

This is a definitive insertion and must date to Pitt's renovations which finished around 1711. Its architectural style presents a strongly marked contrast to the Gothic qualities of the rest of the screen in its uncompromising classical post-Renaissance form and is highly redolent of the late 17th/early 18th century auditory church architecture of Wren and Hawksmoor etc. (Jones and Smith 2017). The fact that the rest of the chancel screen has been remodelled from a previous or refitted medieval oak screen or screens and the softwood arch inserted implies that if this is an element of the Pitt refurbishment a conscious decision was made simply to open up the chancel by means of the arch and its half doors rather than to remove it or completely rebuild it in a more contemporary neo-classical style. Perhaps a money-saving decision was made here. At any rate, the retention of the screen also suggests that the moderniser was a traditionalist, not just from the nature of the ornaments added to the beam but from his (?) desire to delineate the chancel pews from those in the nave by means of maintaining this architectural barrier between them, thereby continuing to enhance the status of those occupying the chancel pews.

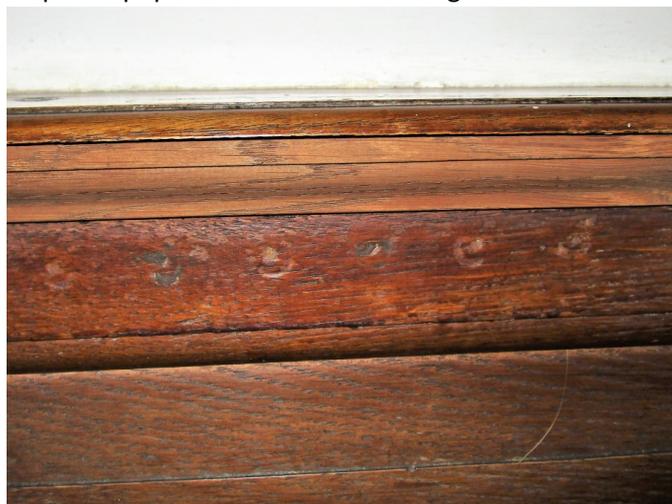
Fig. 19 Detail of marks left by upholstery studs in upper panelling band of northwest box pew of the chancel.

The northern pew up against the chancel arch has indications of tacked upholstery all around the pew, with the exception of the panelling of the screen and the panelling on the chancel arch (see Fig 19). However, there are no surviving tack marks at floor level on east and south sides, suggesting that those pew sides have been lowered. It is possible that this lowering of the pew walls was carried out over the whole chancel and this theory is supported by scarring on the north eastern pew. In the centre of the wall panelling is a scar for a cross wall at the same height as the wall panelling.

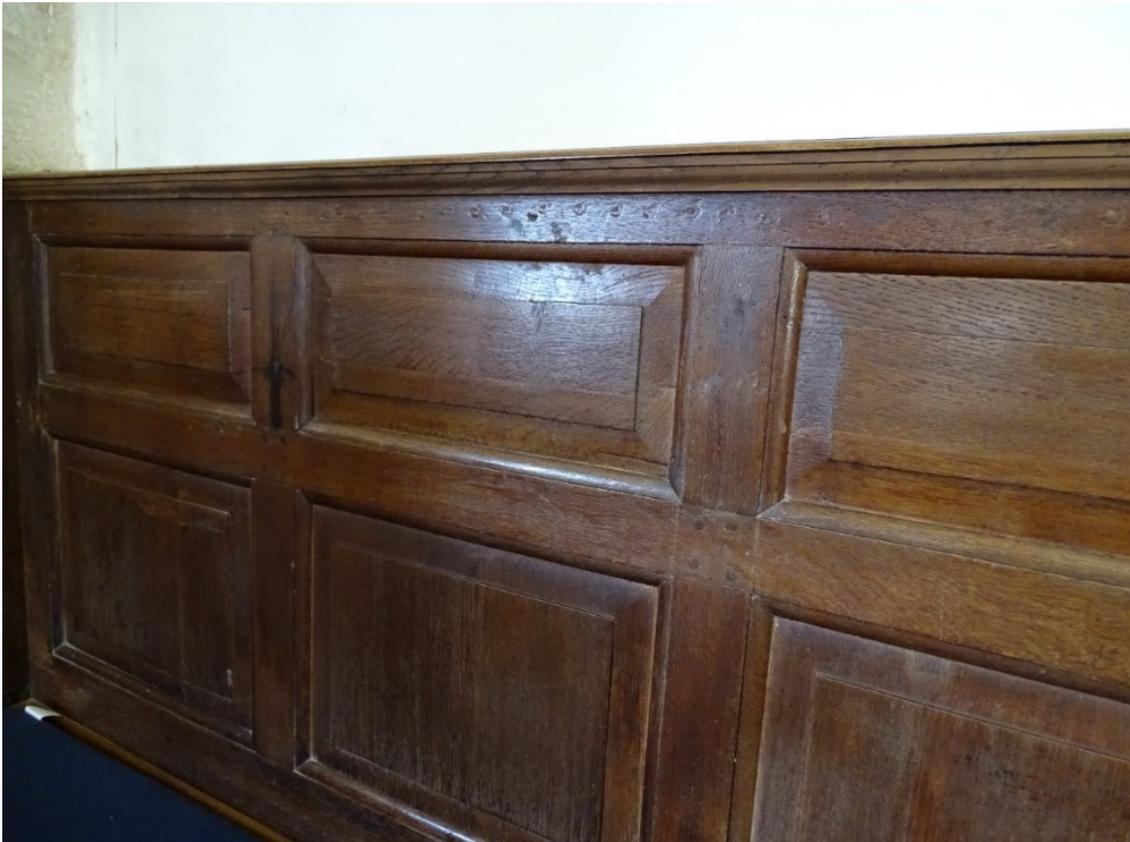
Fig. 21 North pew panelling with upholstery stud marks at the top and 17th century double pegging.

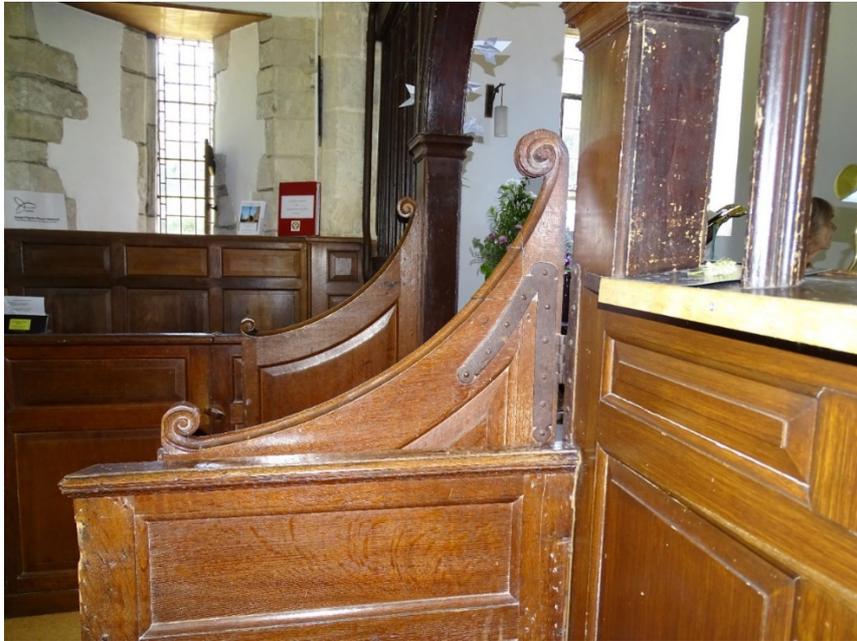
Fig. 22 View of north and south box pews and half doors with heavy bracket hinges.

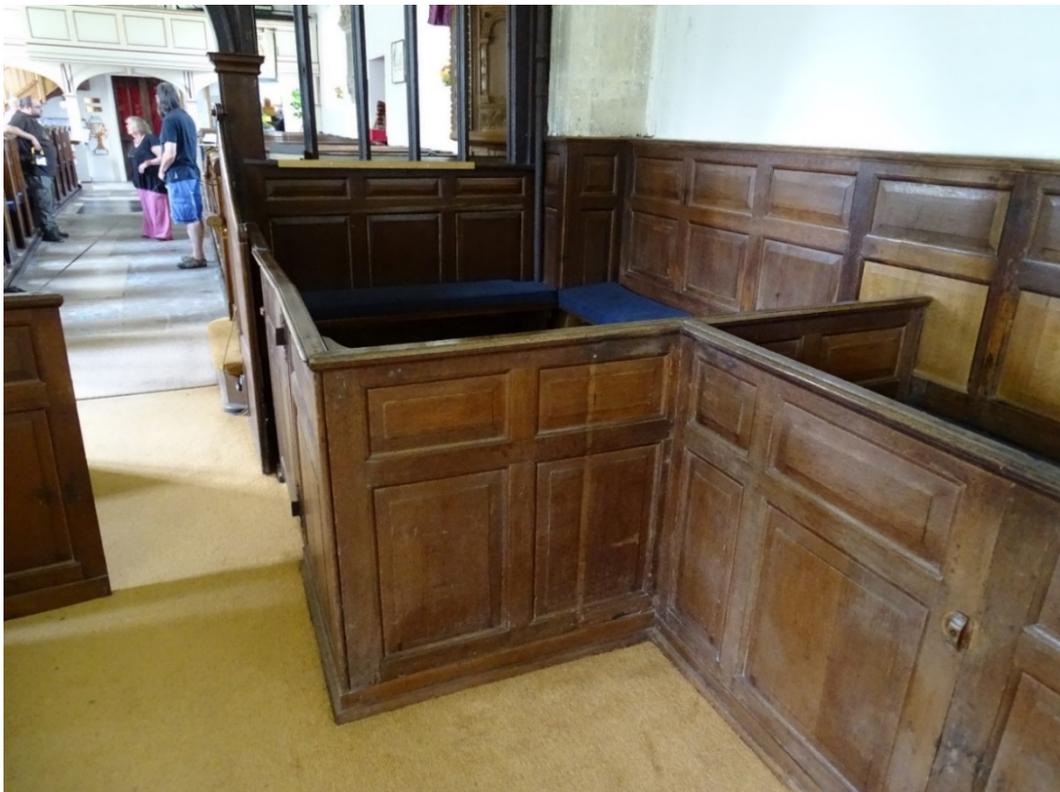
Fig. 23 Chief gentry pew and presently undivided long pew to the east, but note scar on timber where the front of the long pew may have originally been set.

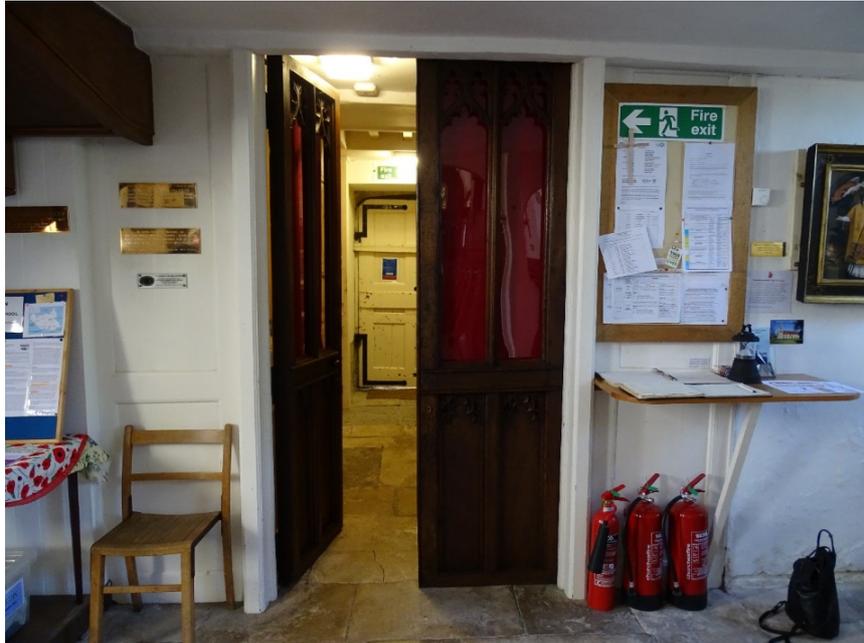
Fig. 24 West internal tower doors. There is a tradition that these doors came from the screen.

The doors to the west tower have traditionally been considered to have originally come from the screen. However, we cannot see any surviving evidence for this. The doors are seated in some substantial timber framing of a Georgian or earlier date, creating a wall across the opening. The width of the doors contradicts the supposition that they are from the screen because their combined width is 129cm, and the opening in the chancel screen is only approximately 116cm. The huge folding hinges are too large for the doors and overshoot the posts (*see fig. 25*). The lower ones may have some age but the upper ones are blacksmith made in the last hundred years.

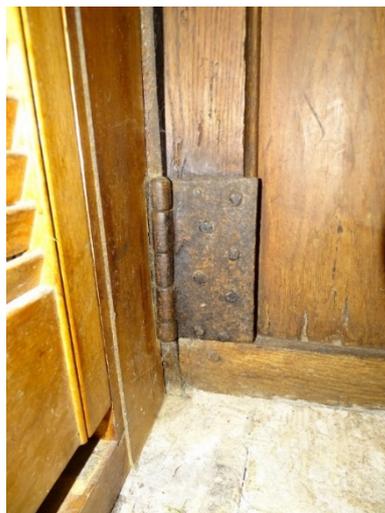
Fig. 25 Lower hinge to interior West door

The doors themselves have some original timbers but most are replacements (and the older ones were possibly more substantial as indicated by the hinges). All of the tracery and spandrels of the doors are imitative of the screen's tracery and the middle band is also similar (*see Fig 26*). Since we think that the screen is a composite of three phases, this implies that the doors were created after the present screen had been established. It seems likely that these doors are accordingly a replacement made to match the screen.

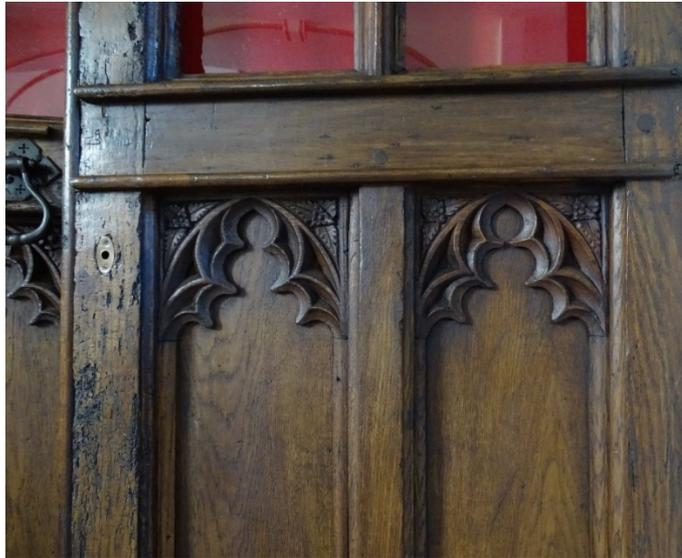
Fig. 26 Detail of tracery on the interior West doors.

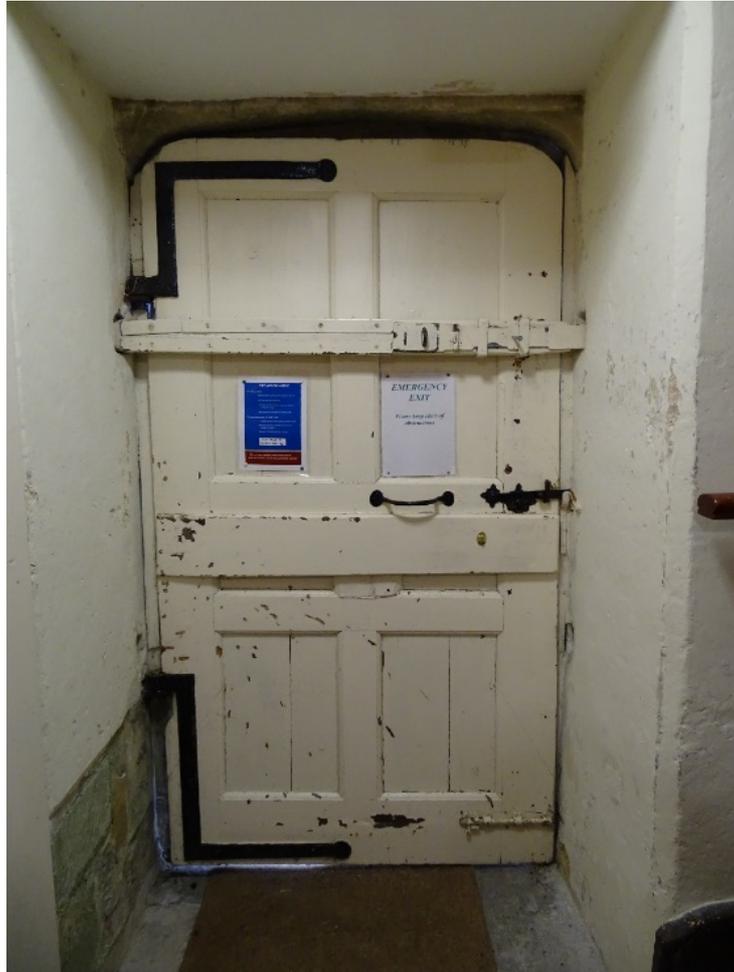
This is a Georgian 6 panel door with quarter bead moulding (*see Fig. 27*). The top of the door is flat with rounded corners but is set into a 4 centered arch so there is a mismatch and therefore it is not the original west door. The hinges are substantial iron straps fitting onto a pintle (vertical bar) hammered into the wall, a technique that was uncommon after the Jacobean period (Calloway 1996: 19). The lower pintle, in particular, does not appear to have any age (it is shiny and without rust!) and must be a replacement. Missing wood on the door close to the hinges suggests these are also replacement hinges.

Mortices on both side of the door frame are in place for bars to go across internally, suggesting a great need for security when the tower was first built, unlikely at the date shown on the outside (1711). Can we suggest therefore that, during the Pitt refurbishing, the tower was only partially rebuilt including refacing on the western exterior elevation where it shows very fine chequerboard knapped flint, in contrast to the other sides of the tower? We note the church's northern exterior also boasts more ancient flint chequerwork which was popular during the 14th century and which tends to confirm St Lawrence's significance as a parish church during the late medieval period.

Fig. 27 Interior view of outer West door with surviving bar in place.

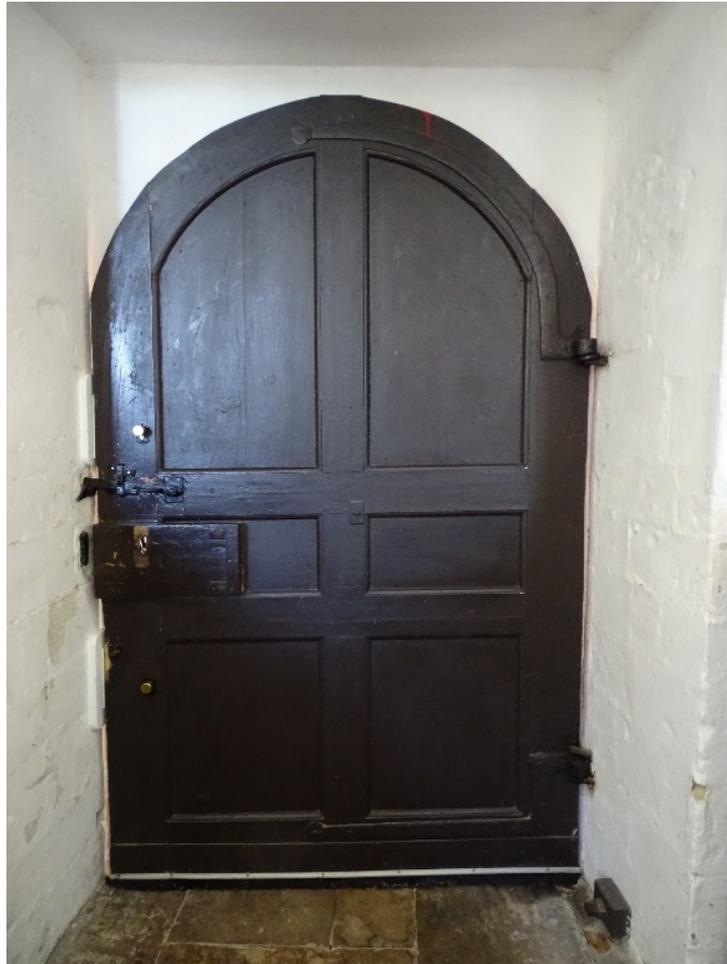
This is a Georgian door with an arched shape and enormous strap hinges similar to the outer west door. Interestingly it has a metal bar driven in above the lower west pintle to prevent lifting the door, suggesting again a greater need for security. We have also noted that the lock plate is upside down - possibly an apotropaic sign, to ward off evil?

Fig. 28 Interior view of South door

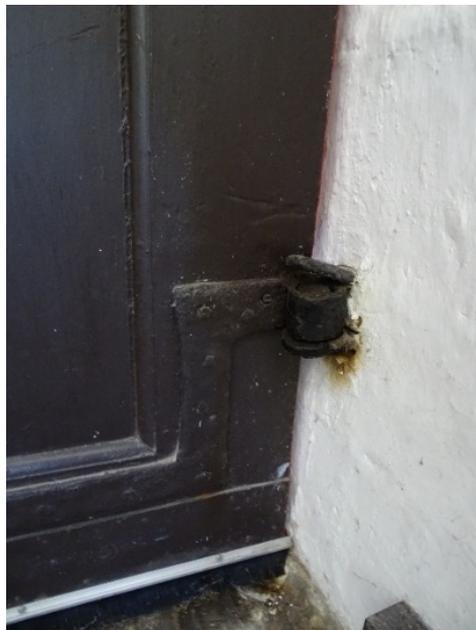
Fig. 29 Pintle with bar across the top preventing the door from being lifted off its hinges.
